# **FABRICATION AND VERIFICATION TESTING OF ETM 30 CM DIAMETER ION THRUSTERS**

**FINAL REPORT**

**ION PHYSICS DEPARTMENT STAFF  
HUGHES RESEARCH LABORATORIES  
A DIVISION OF HUGHES AIRCRAFT COMPANY  
3011 MALIBU CANYON ROAD  
MALIBU, CALIFORNIA 90265**

**CONTRACT NAS 3-17803  
JAMES S. SOVEY, PROGRAM MANAGER**

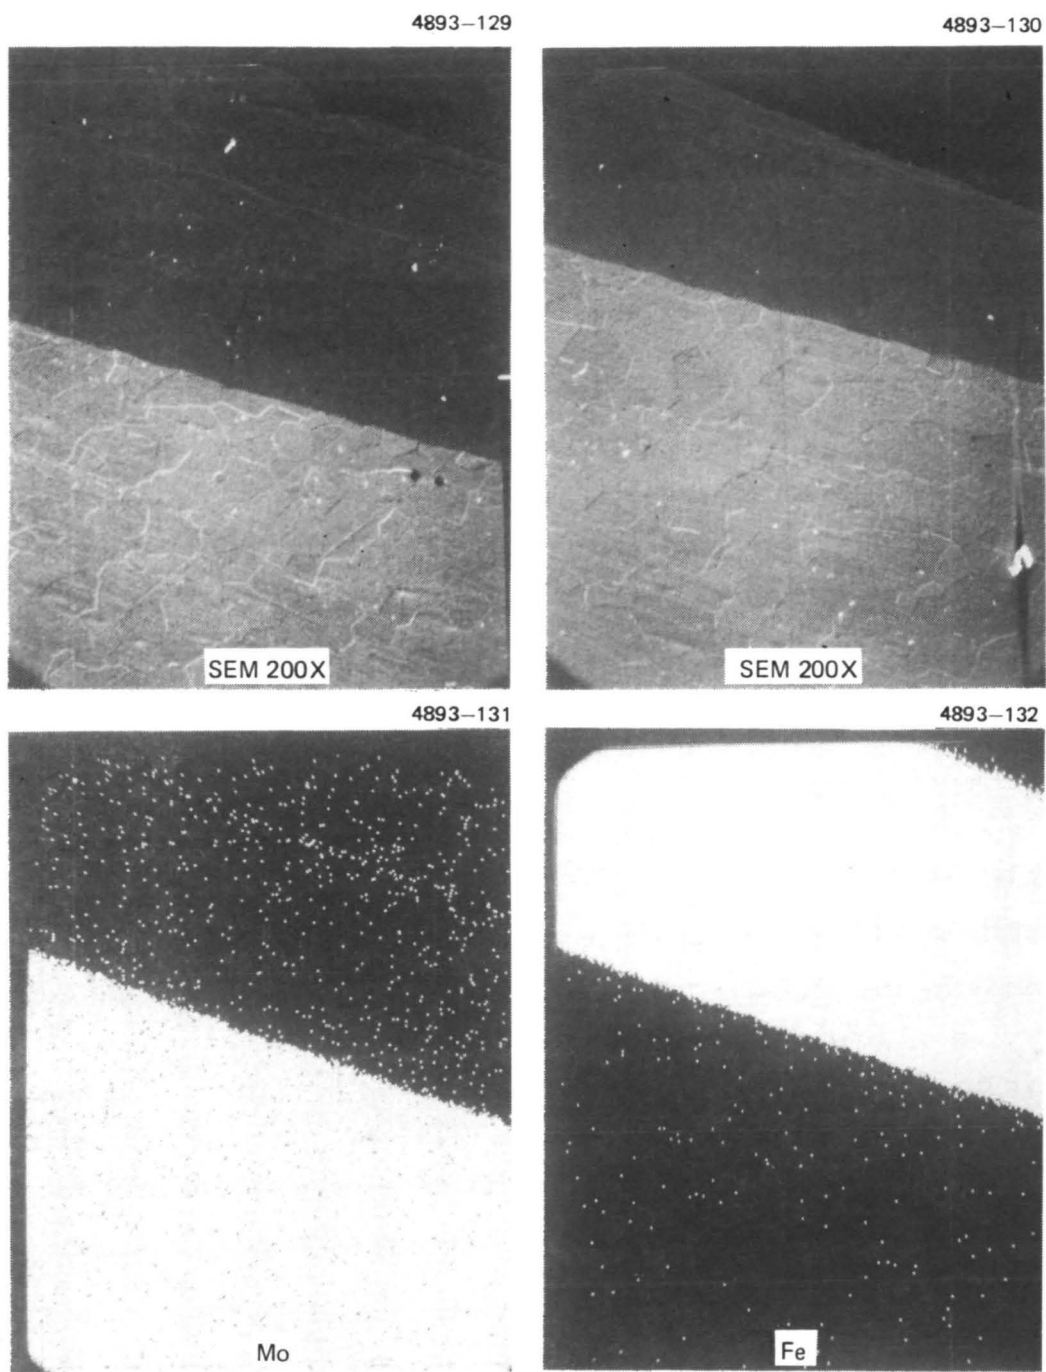
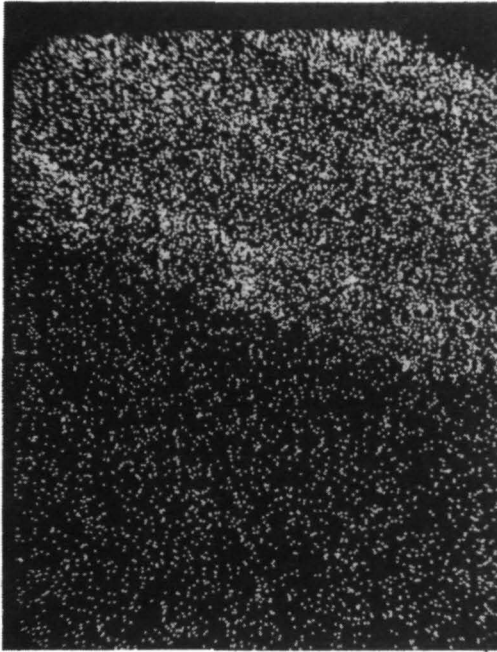
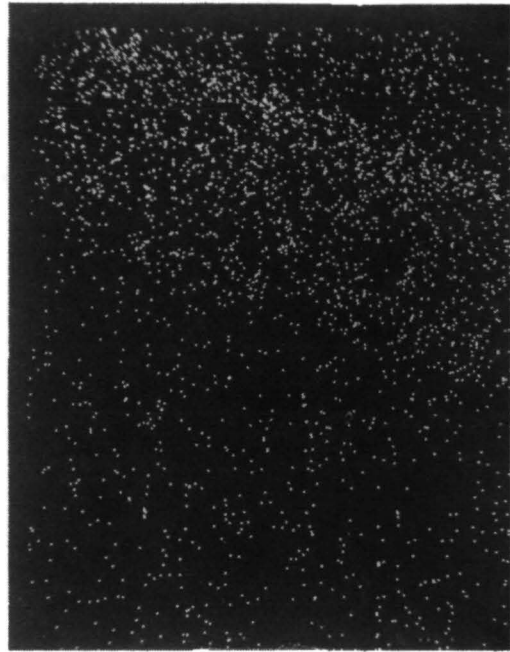
Figure A-50. SEM photo and  $K_{\alpha}$  X-ray analysis of downstream keeper coating.

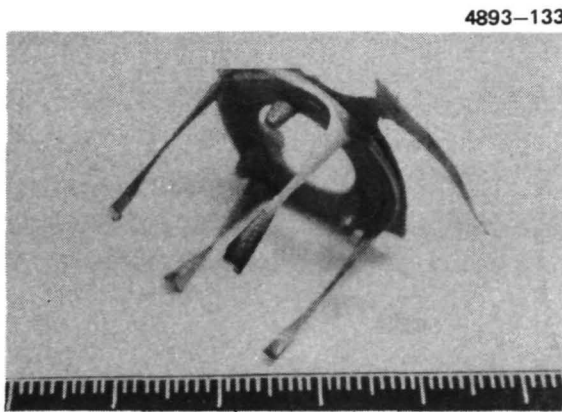
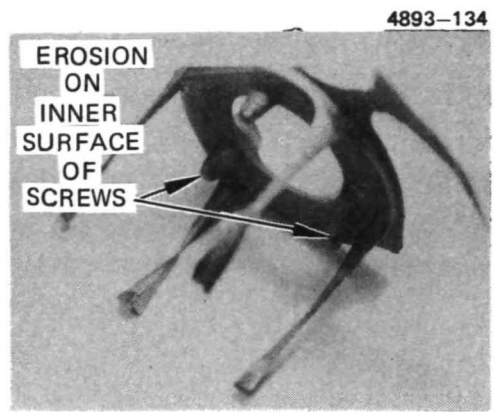
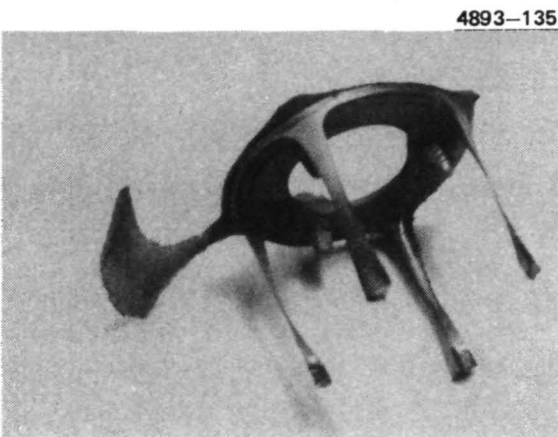
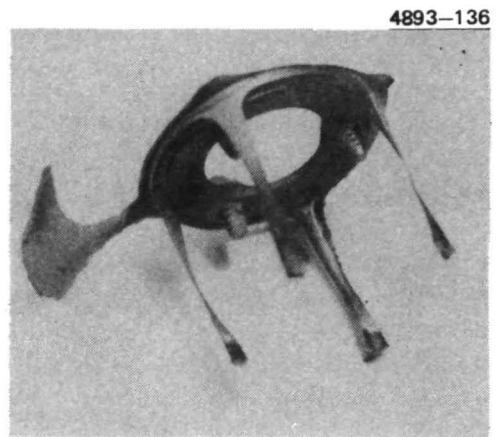
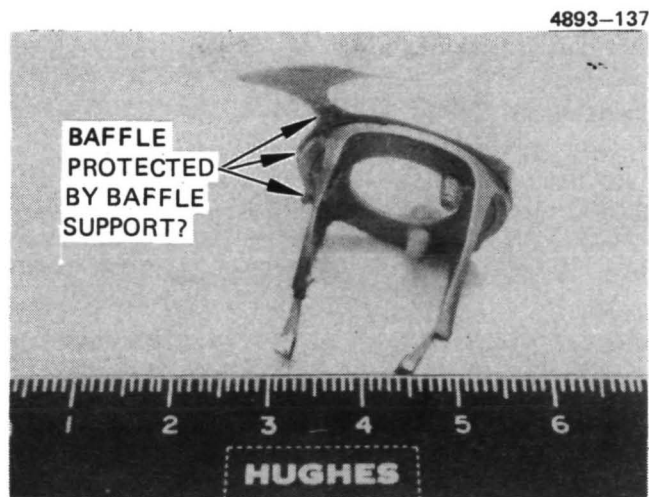
It is apparent in Figs. A-43 and A-44 that removal of the machine screws which secure the baffle to its support is a questionable operation because of the erosion of the baffle supports, which weakens the structure, and because the heads of the screws are eroded to the extent that they cannot be gripped by any tool. After several unsuccessful attempts at removing these screws, the entire support was removed with a high speed abrasive wheel. Several photographs showing the structure as it was removed in several views and variations in focus are included in Fig. A-51. Note that the erosion on the baffle fastening screws is predominantly on the inner side. It is also of interest to note that a thin lip of the baffle remains extending beyond the outer diameter of the baffle support, as if the baffle had been shielded from internally generated ions by the baffle support (further evidence to support the concept of erosion by ions from the cathode plasma). The wear on this structure is documented and recorded in Fig. A-52 by dimensional measurements at the locations indicated. The most wear occurred on Member C, in agreement with the asymmetry in wear seen on the baffle itself and the pole piece.

Figure A-51. Baffle support.

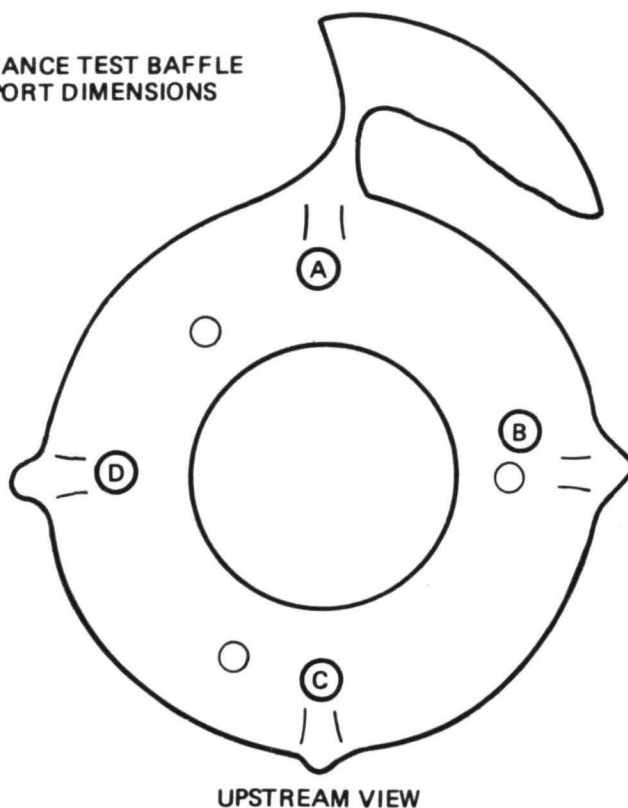
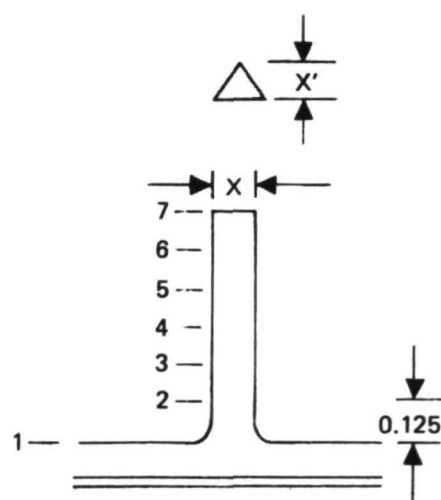
A	A'	B	B'	C	C'	D	D'
1	0.135	0.053	0.132	0.057	0.131	0.052	0.134	0.054
2	0.082	0.047	0.084	0.048	0.081	0.037	0.090	0.043
3	0.080	0.029	0.062	0.030	0.052	0.021	0.070	0.030
4	0.030	0.008	0.055	0.020	0.019	0.003	0.052	0.017
5	0.057	0.021	0.072	0.030	0.037	0.020	0.068	0.027
6	0.086	0.047	0.090	0.047	0.077	0.045	0.089	0.045
7	0.102	0.050	0.106	0.051	0.102	0.049	0.108	0.045

Figure A-52. Endurance test baffle support dimensions.

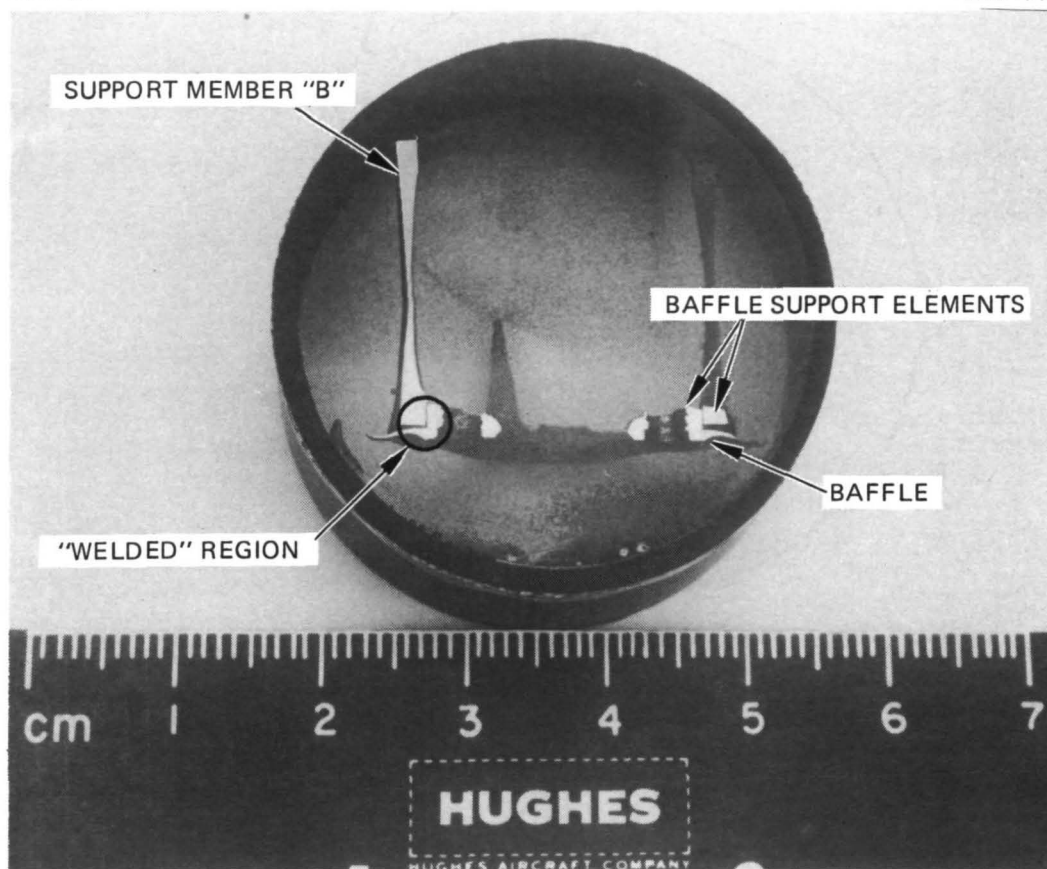
Having documented the support structure in this manner, a second attempt at removing the baffle fastening screws proved successful, but the baffle still could not be removed and was found to be securely "welded" in place. The assembly was then sectioned as shown in Fig. A-53, and the "welded" region was identified as a nickel "brazed" by means of the E-beam microprobe analysis shown in Fig. A-54. It is thought that the nickel coating placed on the mild steel parts to prevent oxidation is responsible for the "welding" of these parts. It is

Figure A-53. Magnified view of baffle support cross section.

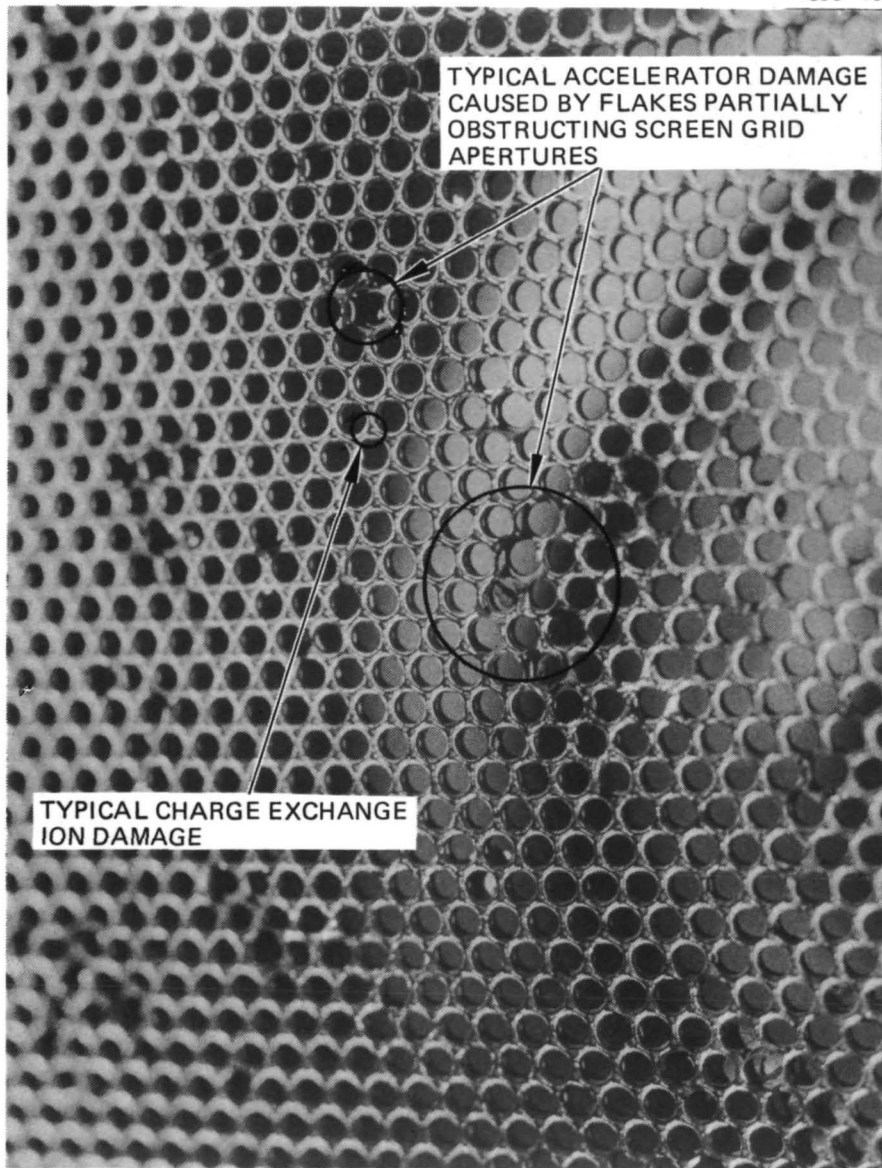
Figure A-57. Accelerator electrode, downstream view.

electrode was caused by direct interception of high-energy ions which were deflected or defocused by flakes of material partially covering screen grid apertures (as seen earlier in Figs. A-1 and A-12). Several examples of damage of this type are pointed out in Fig. A-57. The typical pattern of "pits" and grooves caused by charge exchange ions is also seen. Photographs comparing the downstream side of the accelerator electrode before and after testing are shown in Figs. A-58 through A-67. By careful examination of these photographs (or the actual electrodes under a microscope), it is seen that the ion machining damage is randomly distributed and irregular in form. The erosion caused by charge exchange ions, on the other hand, is quite uniformly distributed and exhibits a well defined pattern. This pattern is oriented to the hexagonal aperture array but does not show any region of accelerated wear that would indicate the neutralizer location. Thus, the major difficulty observed in the SERT II tests is not at all in evidence here.

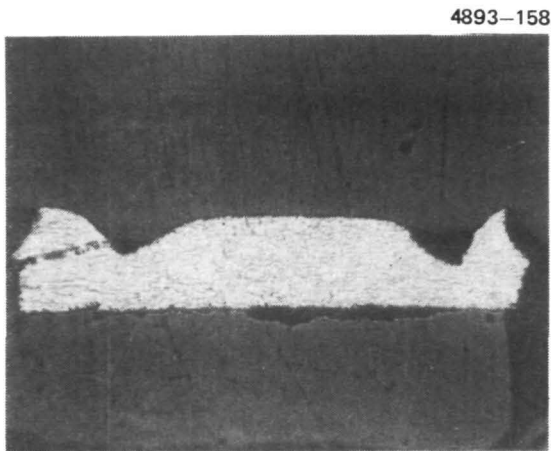
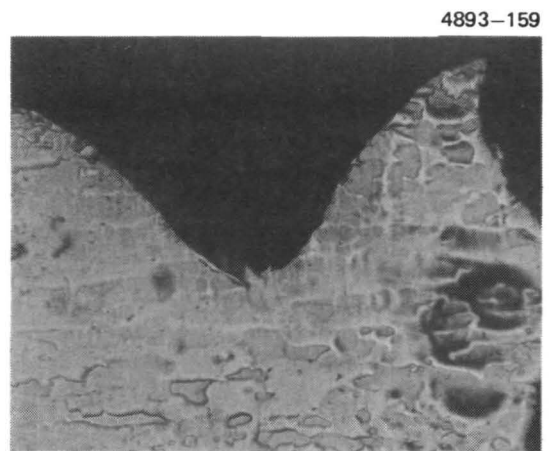
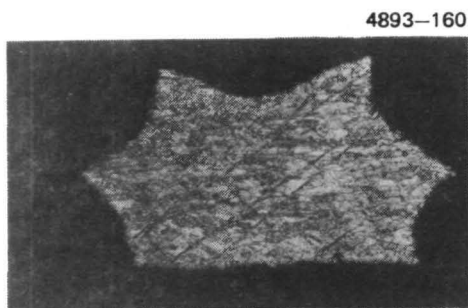
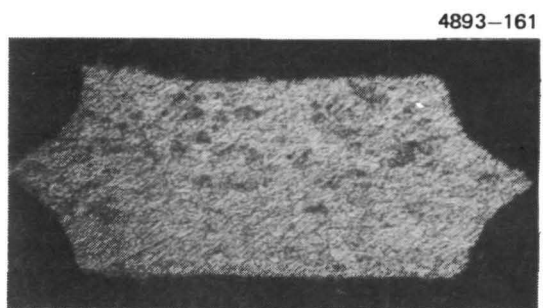
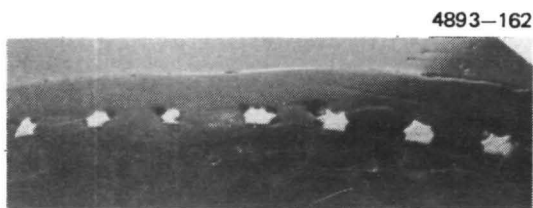
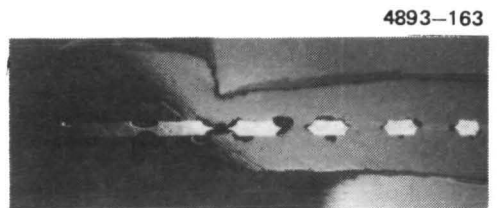
Figure A-69. Selected cross sections of accel electrode.

The depth of the charge exchange erosion was investigated carefully, both by microscopic examination and by cross-sectioning segments of the electrode taken from the center and the edge of the grid. The "pits" are seen as triangles (Fig. A-68) in the center of the web of material common to any three apertures. These pits vary but are usually almost conical in shape with a very small cross section at the deepest point. They vary in depth from a maximum of 0.013 in. (0.033 cm) near the center to being immeasurable near the edge. The pits are connected by grooves, which are a maximum of 0.006 in. (0.015 cm) deep at the mid-point between pits. The depth and shape of the pits and grooves eroded by charge exchange ions appears to also be influenced by their proximity to defocused beam ion damage. In areas where there is extensive ion machining damage, the pits and grooves are shallower and broader. Figure A-69 shows some selected cross-sections of the accelerator electrode near the center and the edge. The difference in the views shown reflects the location and angle of the cut through the material. The views shown as Fig. A-69(a) and (b) represent a cut along the groove and through the pits, the depth of the pit shown being approximately 0.012 in. (0.030 cm). It is thought that the sample in (b) has been polished to nearly pass through the center of the pit. A survey of pit depth was made using a microscope at high magnification (1000X) and measuring the travel required to focus on the bottom of the pit as compared to focusing on the undamaged edge. A plot of representative pit depth variation is shown in Fig. A-70.

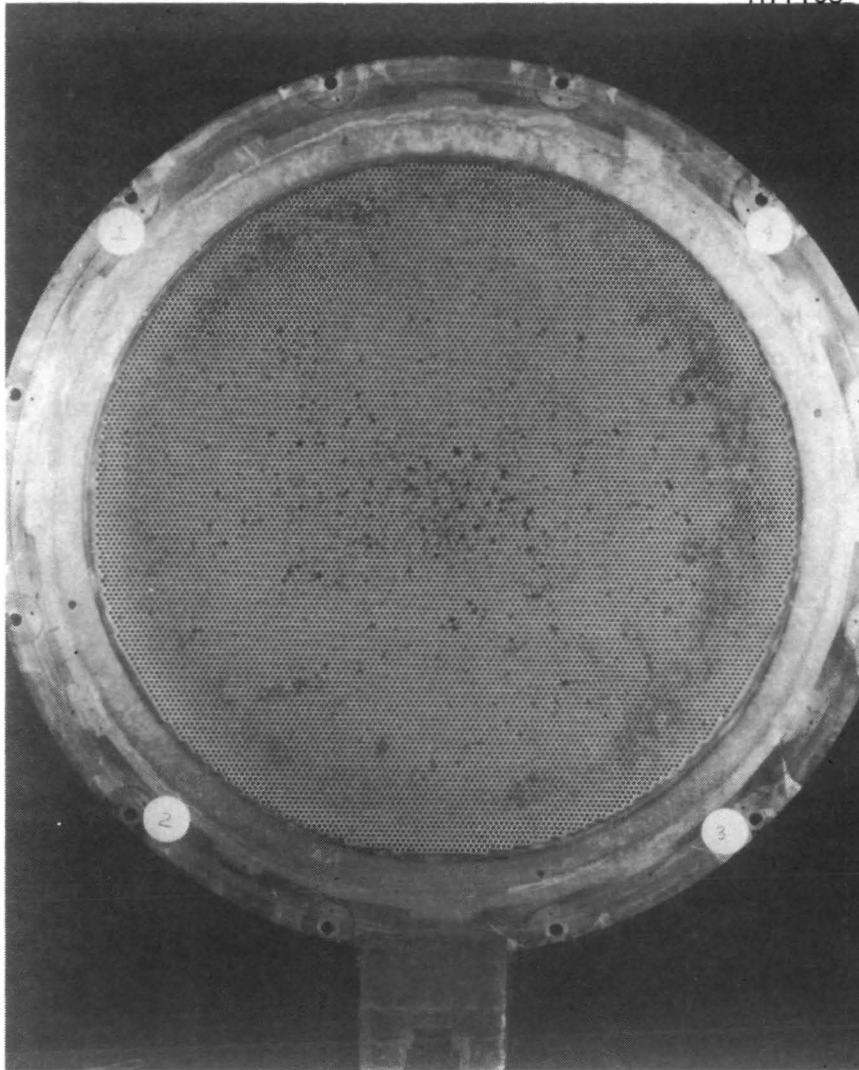
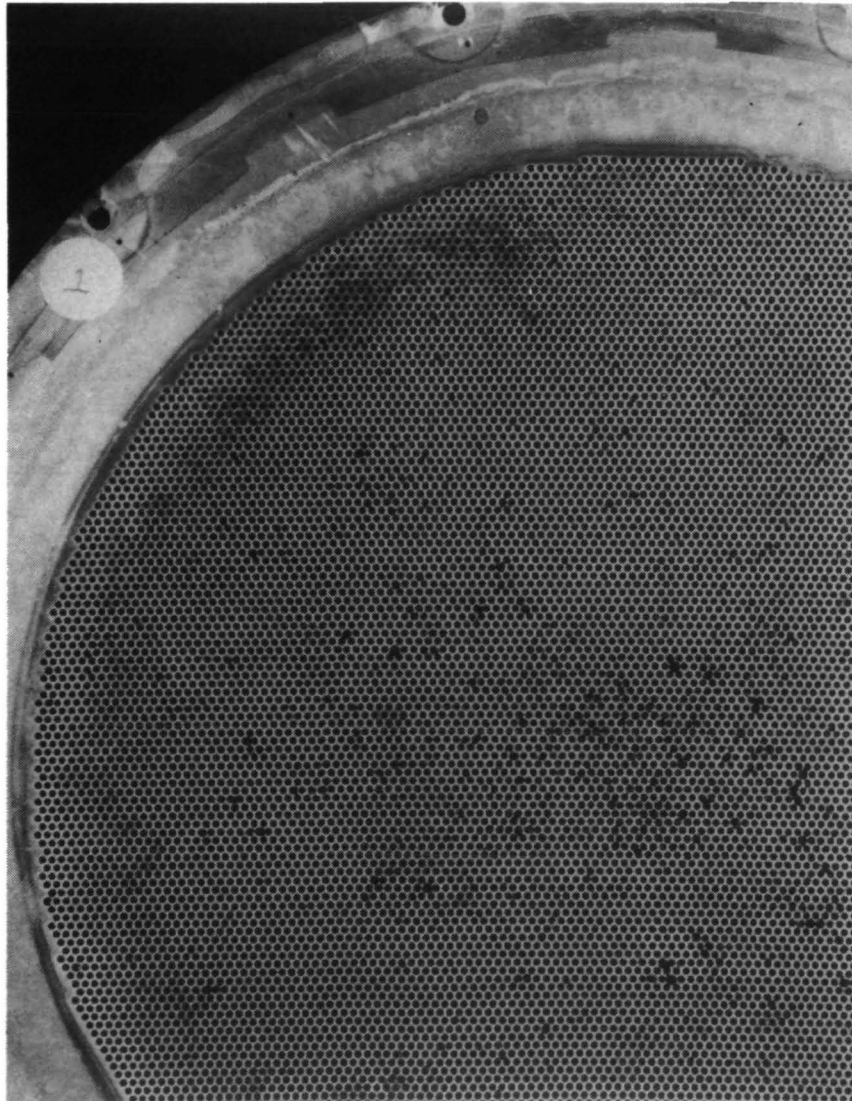
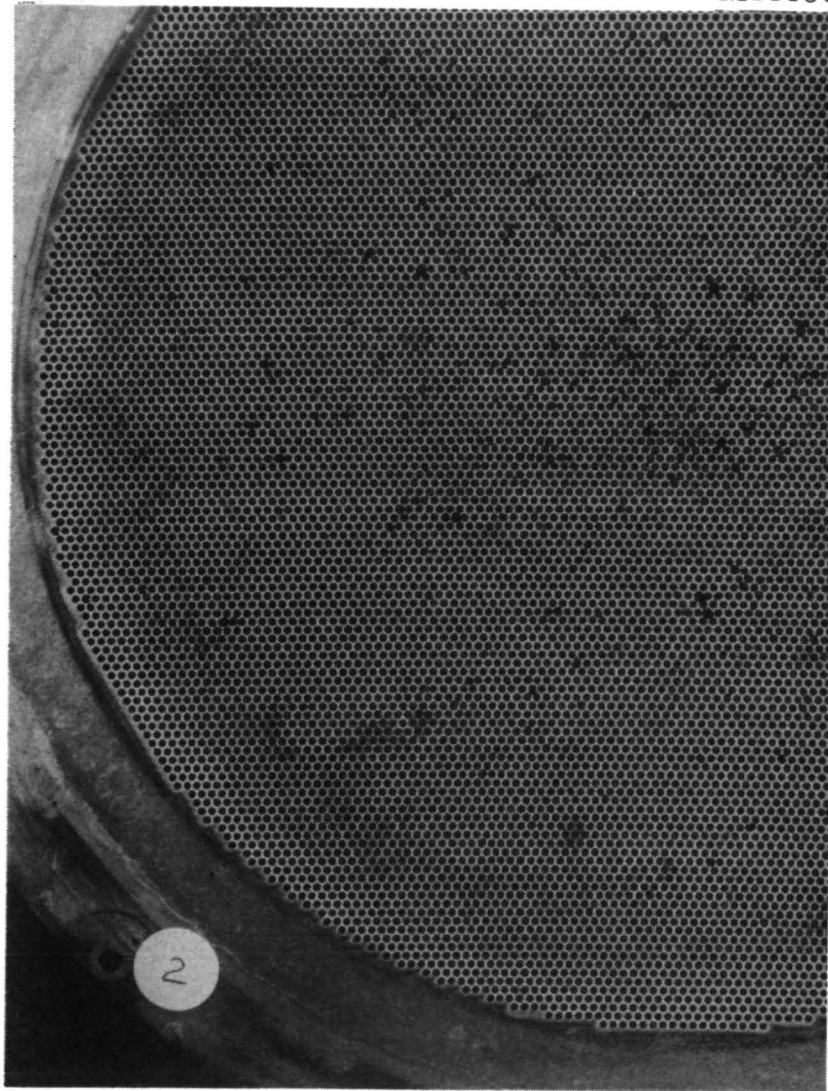
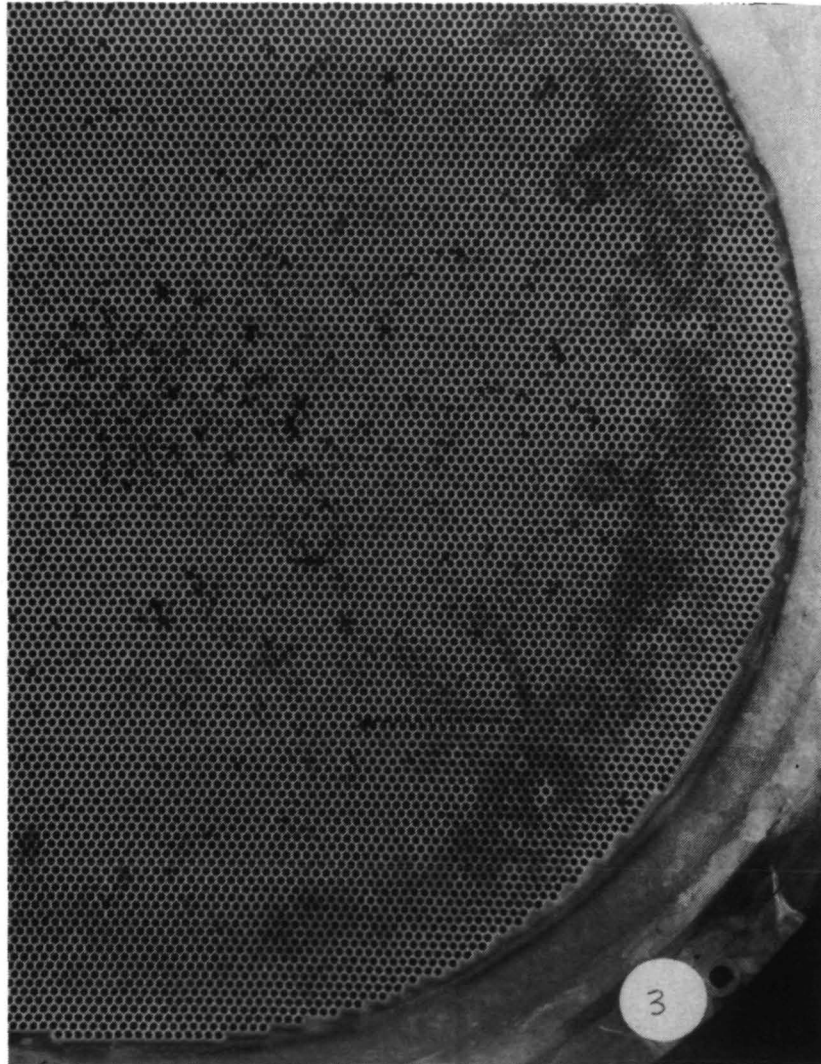
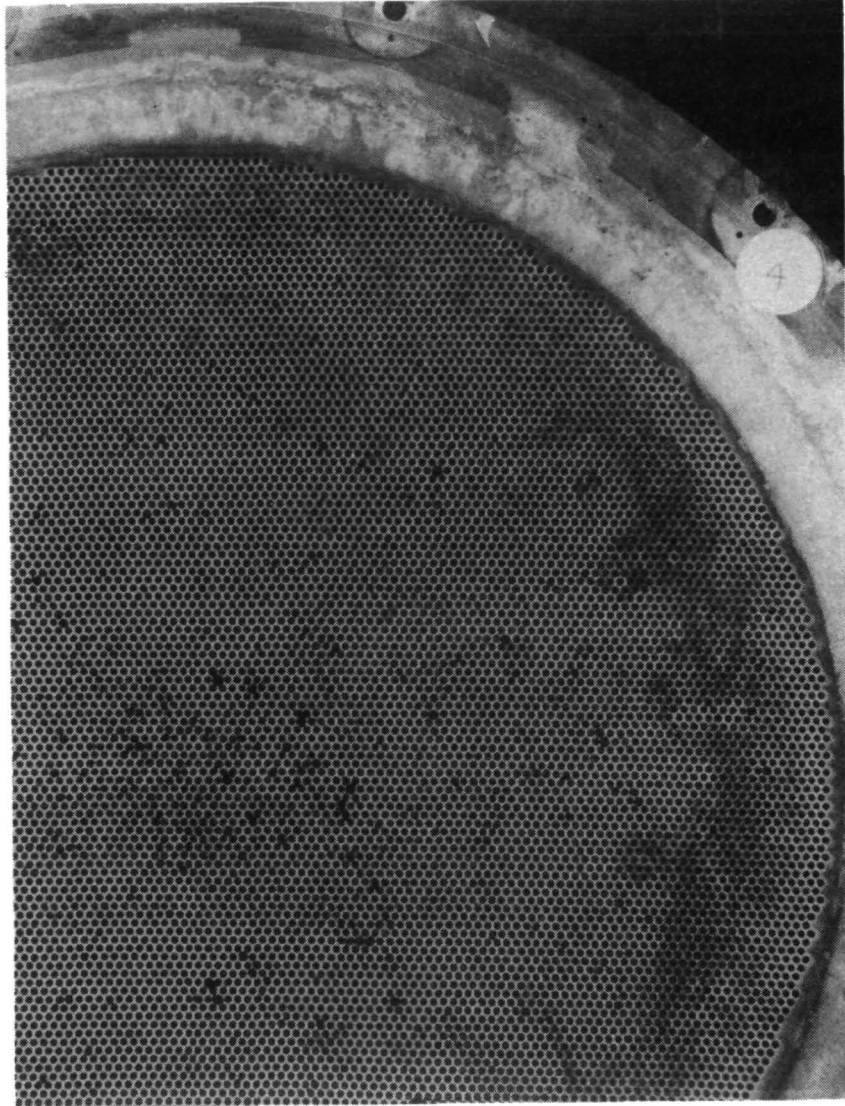
Photographs of the upstream surface of the accelerator are shown in Figs. A-71 through A-75. Careful examination of these pictures reveals several features that have been magnified and included in Fig. A-76. View (a) shows an area that is relatively undamaged but has a "matte" finish that may be the result of low energy ion erosion. Figure A-76(b) shows a typical area in which deflected beam ion erosion has occurred causing "scythe" shaped markings on the grids. This type of damage is rather widespread and, in areas where flakes remained on the screen grid for long time periods, the damage progresses as shown in view (d). View (c) is rather unusual in that the small triangular areas seen in the location that is usually occupied by charge exchange ion erosion pits on the downstream surface is actually a deposition here on the upstream surface. In addition, the edges of the apertures seen in view (c) appear rounded in a chamfered fashion, which is not typical of most other areas on the electrode. No explanation can be offered for the wear seen in view (c). In considering the relatively large number of high voltage overload recycles which occurred during the test, it was thought that arc damage might be distinctly visible on the upstream surface of the accelerator electrode. It has not been possible to identify any damage seen on this electrode with the appearance of damage that is seen when grids are purposely short circuited and the shorting material is then removed by capacitive discharge. This statement does not imply that such damage did not occur, but only that it cannot be conclusively identified.

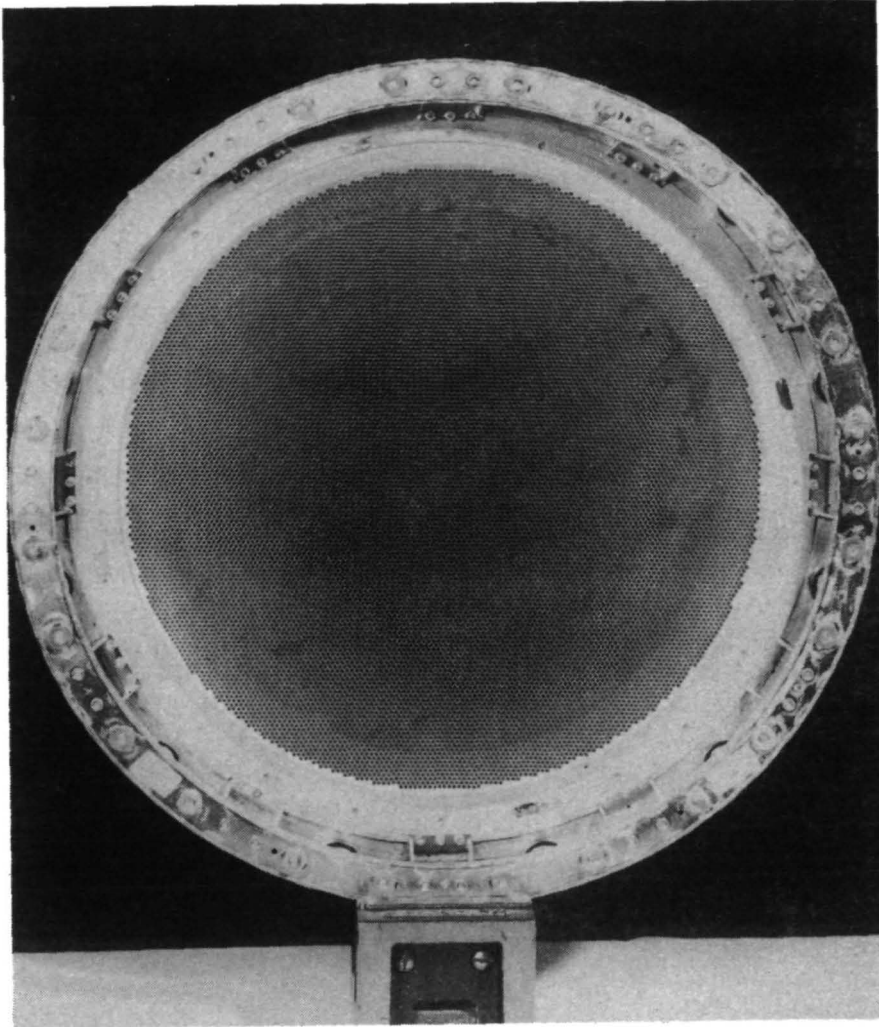
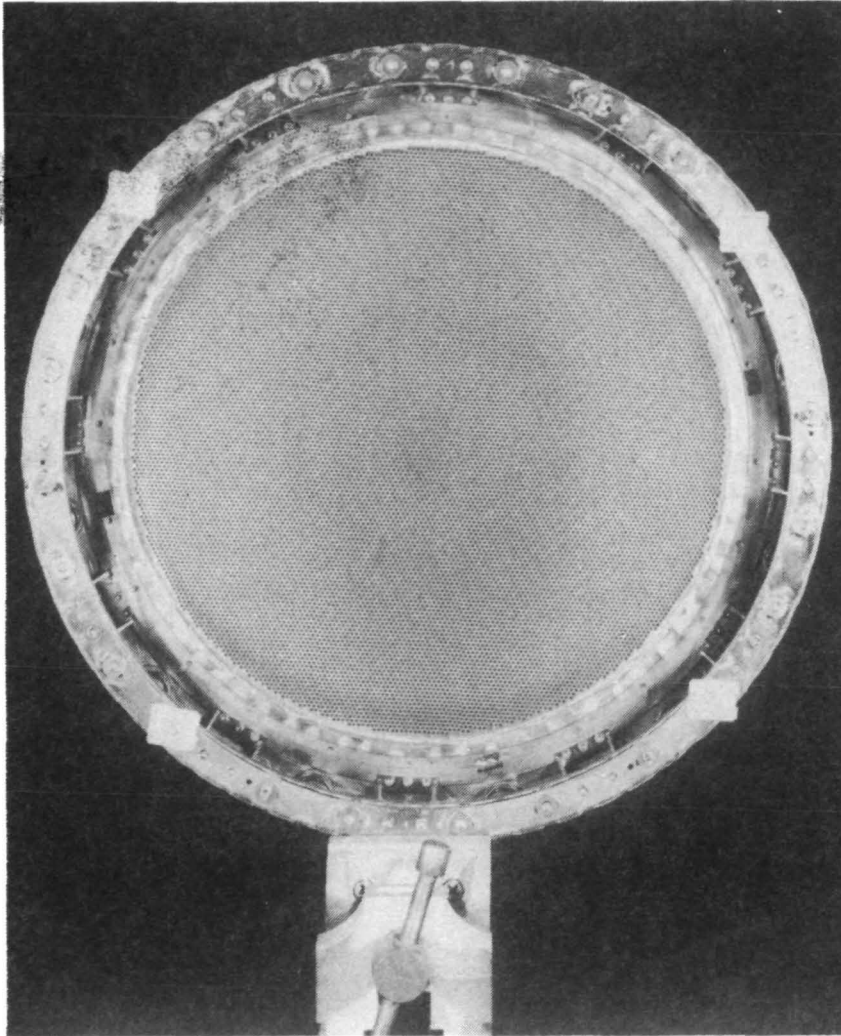
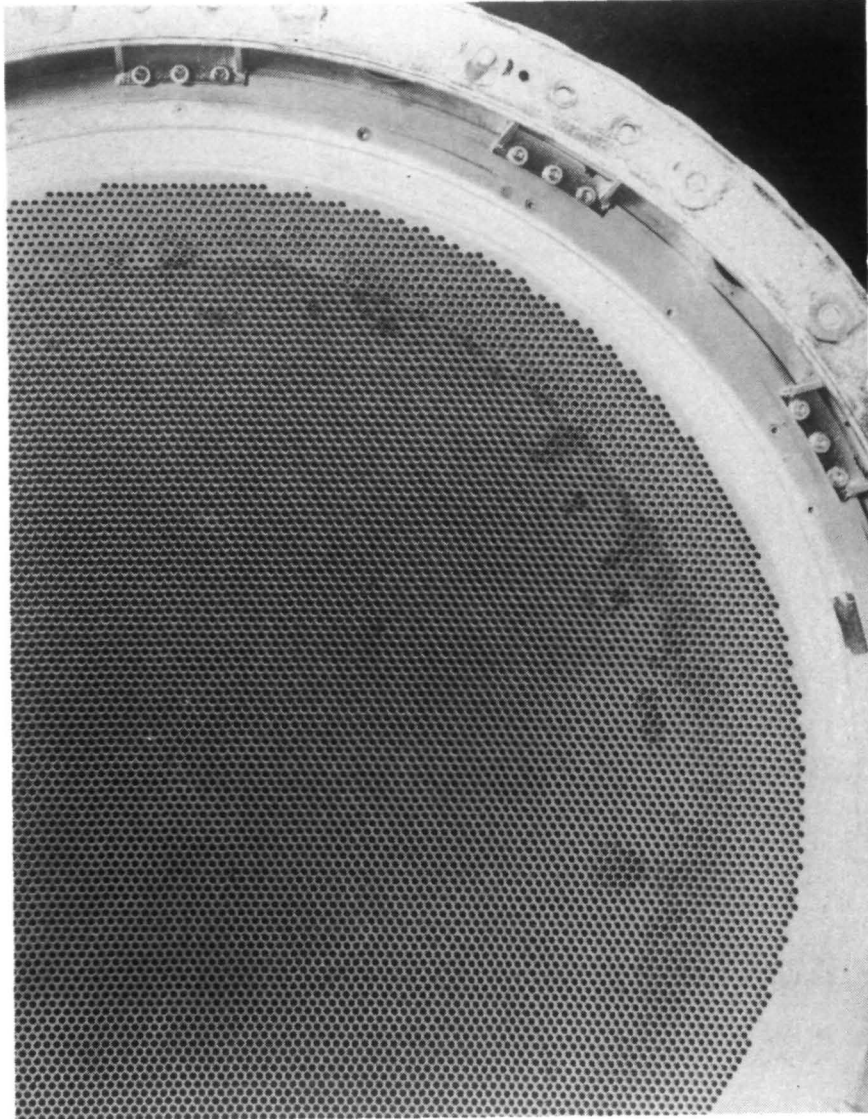
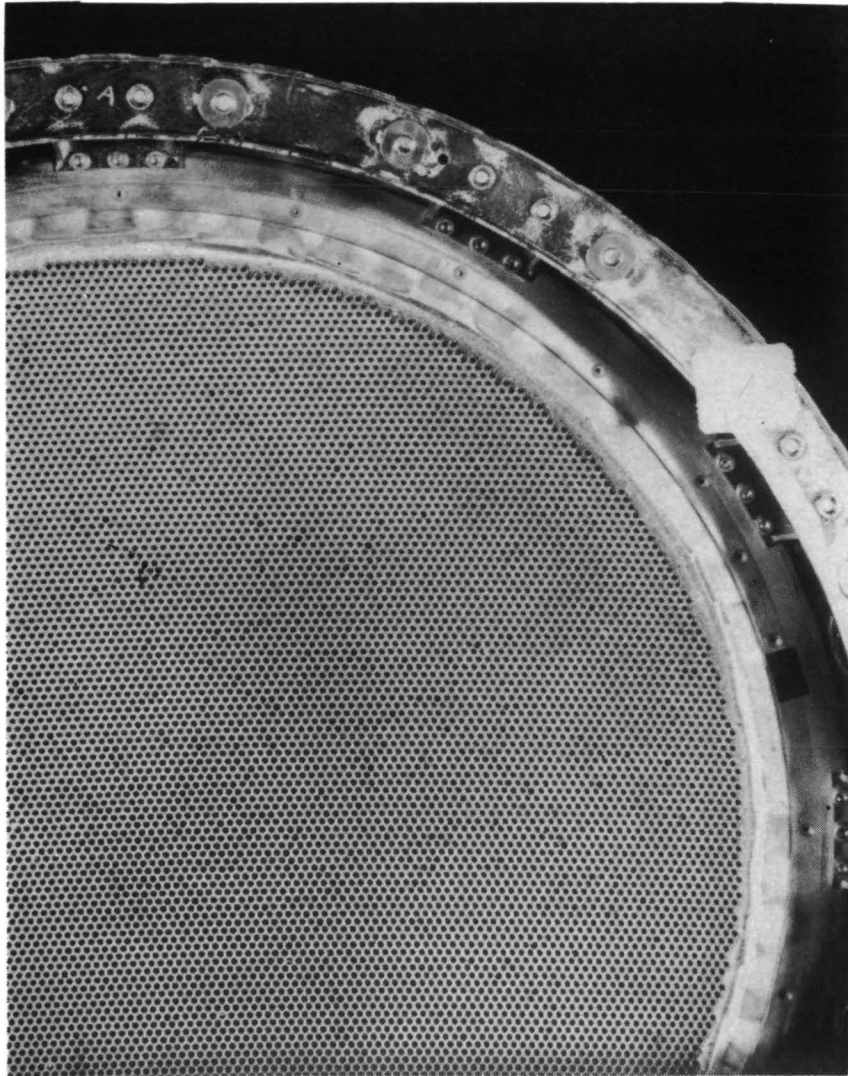
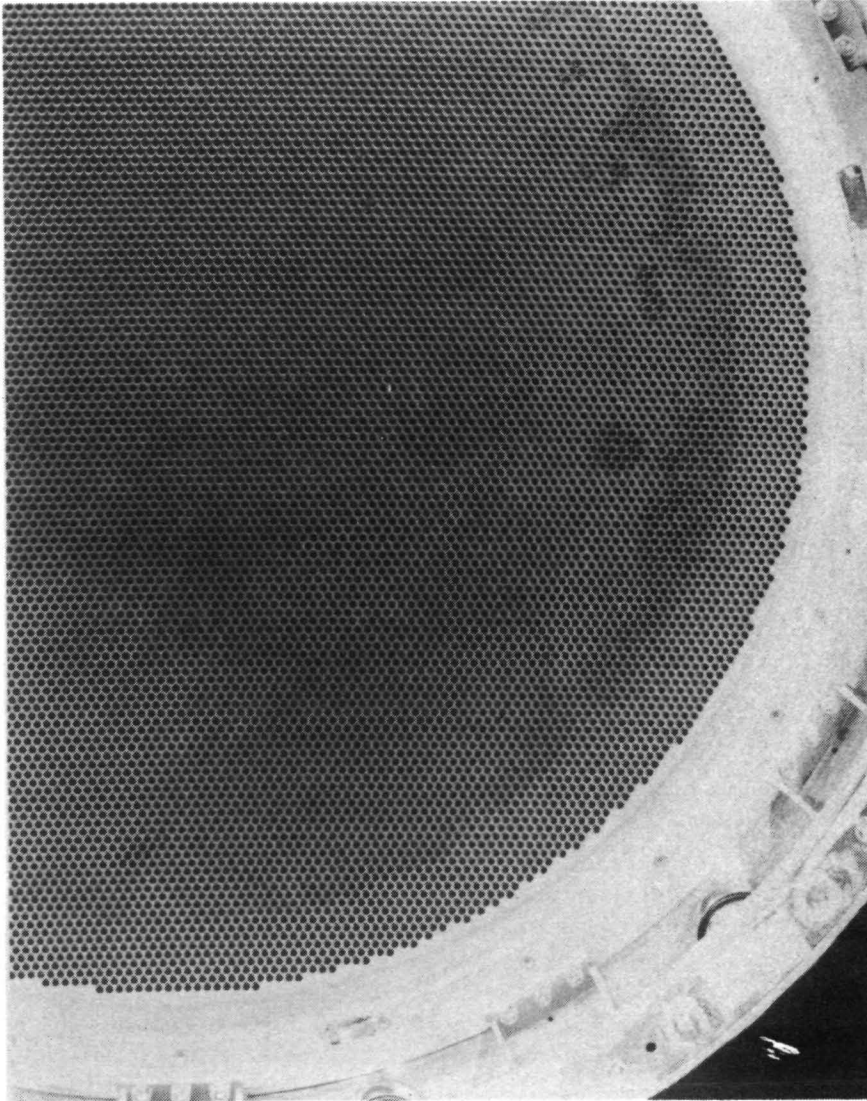
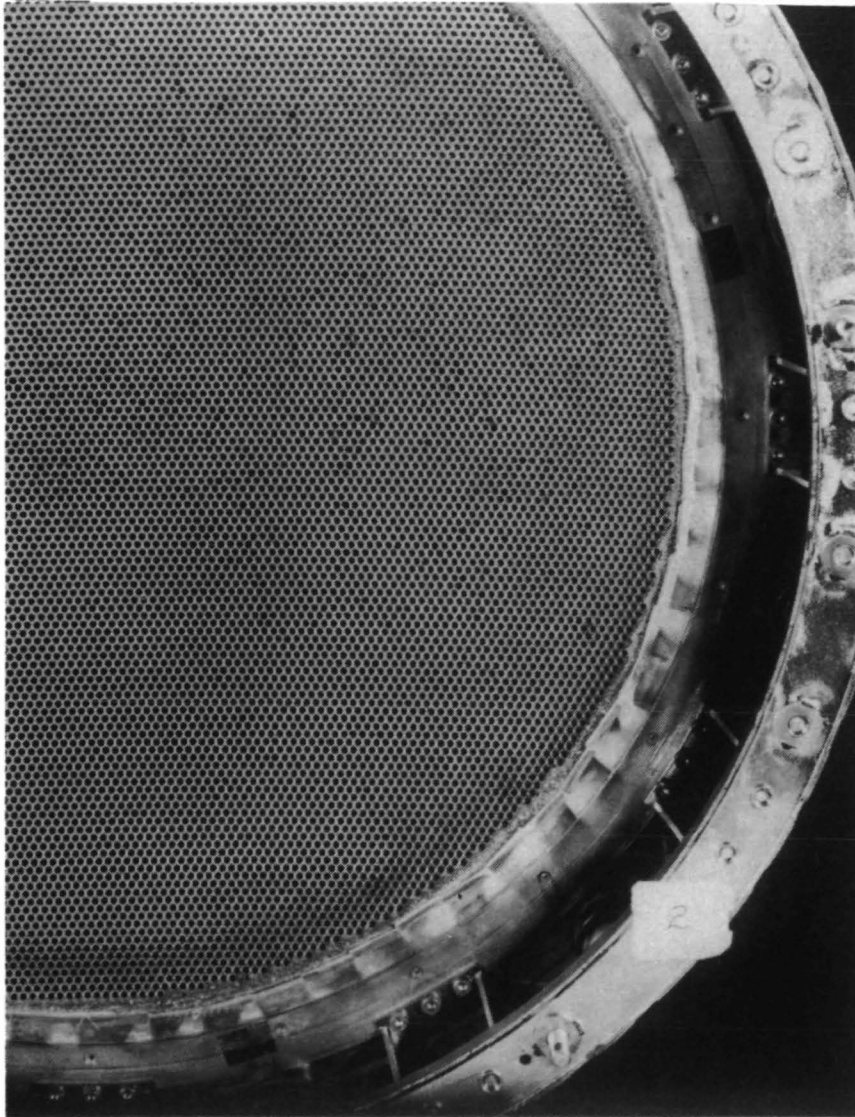
The screen grid electrode has not in the past been of great concern as a factor limiting thruster lifetime. It will be seen in the following paragraphs that appreciable concern is justified. Proceeding in the same manner as above for the accelerator electrode, Figs. A-77 through A-86 compare photographs of the upstream surface of the screen grid before and after testing. It is difficult to detect any differences in the appearance of the screen grid. There appears to be a slight rounding of the aperture edges as seen in views (a) and (b) of the magnified photographs shown in Fig. A-87. These views are representative of the appearance of the center of the electrode, while view (e) shows that such

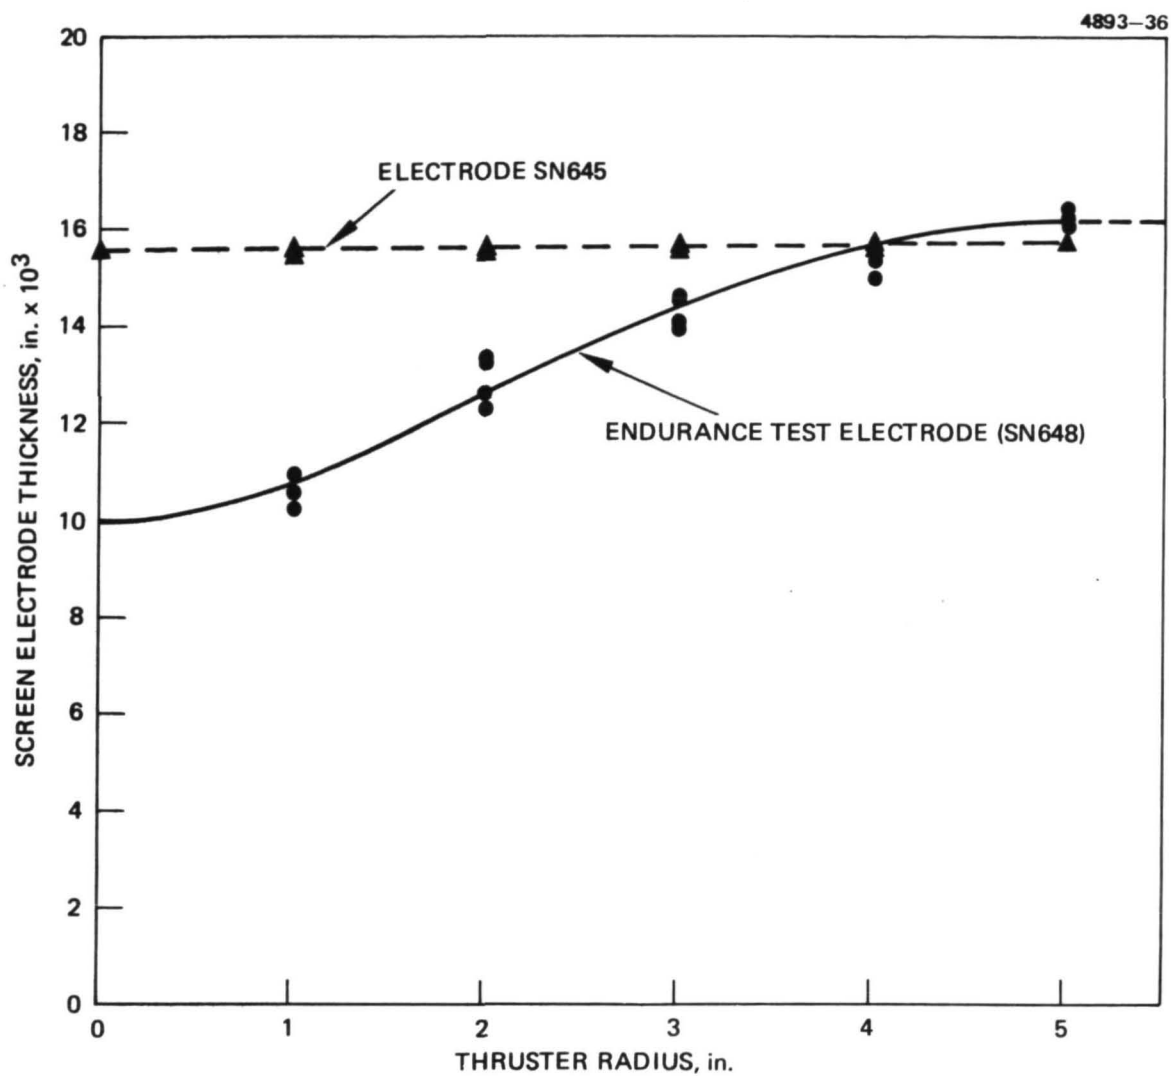
Measurement of the electrode thickness showed the grid to be appreciably eroded and reduced in thickness nearer the center as documented in Fig. A-88. Measurements were performed using the same technique on a slightly used electrode (SN 645) which had been fabricated from the same material lot during the same time period as the endurance test electrode; these values are included in Fig. A-88 for comparison. The erosion seen, like that of the cathode pole piece and baffle, is thought to be a consequence of ion sputtering, predominantly by doubly charged ions. Figure A-89 shows unequivocally the extent of this erosion by comparing cross sections removed from the edge of the grid, in view (a), with several others taken from the center of the grid (views b, c, and d). The minimum thickness of the section shown in Fig. A-89(d) is only about 0.006 in (0.015 cm) thick as compared to the 0.010 in. minimum thickness shown in Fig. A-88 (measured with micrometer). The difference in these values can be explained by the depression seen in view (d) and a coating on the downstream side of the grid that is about 0.001 in. thick. The coating on the downstream side of the screen grid electrode is readily seen in the magnified views shown in Fig. A-90. Figure A-90 also presents the electron beam microprobe scans which identify the elements composing the deposited layer. The molybdenum, iron, chromium, and mercury are expected constituents, while the silicon, aluminum, and potassium originate in the glass used as a "potting" agent (to maintain sharp edges of the sectional sample). The origin of the barium and the chlorine is uncertain, however. Photographs of the entire downstream surface of the screen grid electrode are shown as Figs. A-91 through A-95. It is difficult to see any flakes or deposition in these photographs without magnification. Figure A-96 shows magnified views of what can be seen over the grid surface. Most of the electrode appears as shown in view (a) with a few "patchy" areas like the one shown in view (b). The electrode surface was examined for evidence of arcs, as was done with the accel, but the only marking found that has the appearance of damage caused by clearing a metallic flake is shown as view (c), (circled area). As a consequence of this relatively complete absence of grid damage like that

Figure A-88. Comparison of screen electrode thickness vs thruster radius for endurance test electrode (SN648) after 10,000 hours operation and slightly used screen electrode (SN645).

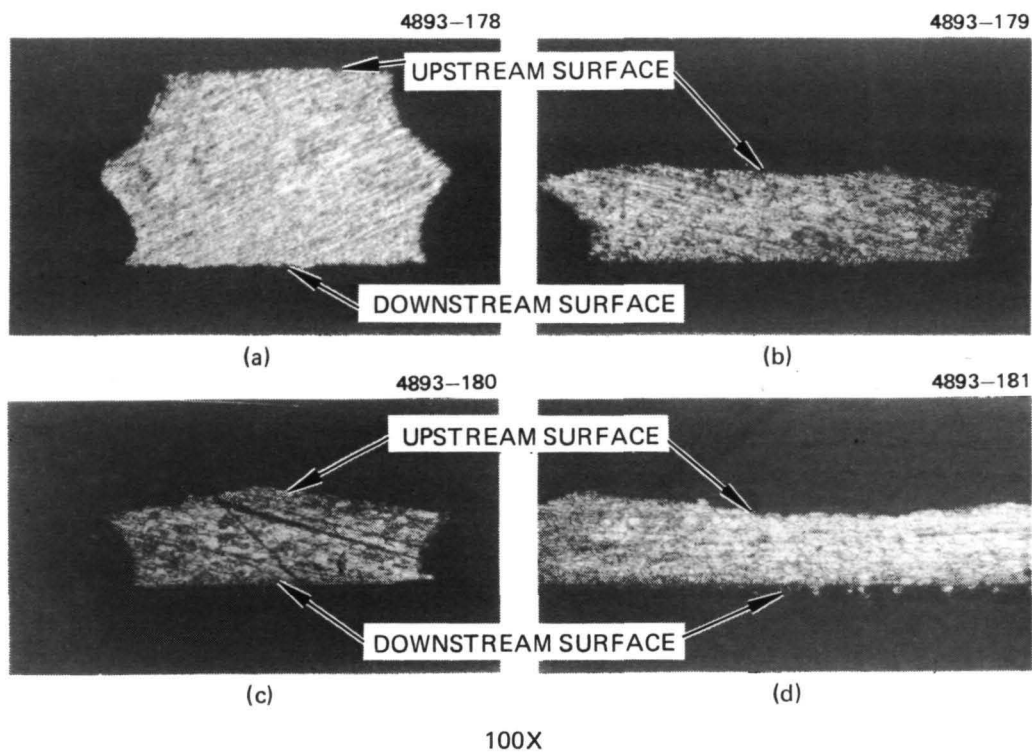
Figure A-89. Cross sections of screen electrode (a) edge of electrode; (b), (c), and (d) center of electrode.
